BAOBAB FARMS DAMAGE ASSESSMENT FORM

Building Name "HICKMAN HSE"
Address 15401 SW 260 ST (HICKMAN DRIVE) Eric Miller (resident)
City (or Vicinity) and County Miami FL 33032 (REDLANDS) 245-2021
Owner STEVE KATZ

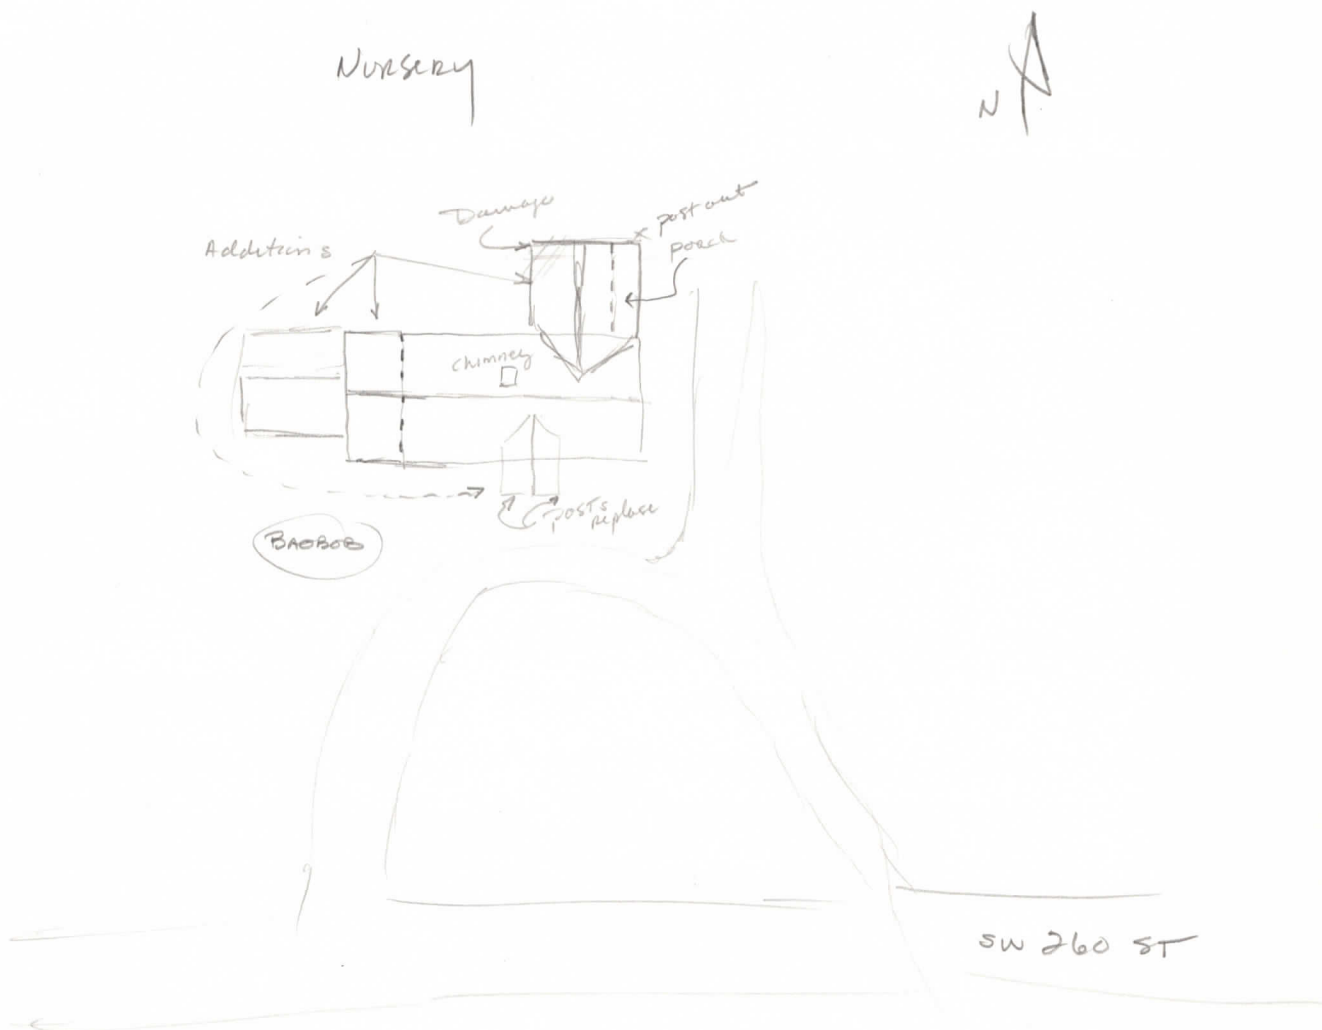
Site Sketch:

BAOBAB - damaged - standing w/ heavy cut back
KAROK - destroyed
Palms - destroyed
